Camp Cleawox Organizational Tract  
Oregon Dunes National Recreation Area,  
Siuslaw National Forest  
Florence Vicinity  
Lane County  
Oregon

HABS No. OR-137

WRITTEN HISTORICAL AND DESCRIPTIVE DATA

HISTORIC AMERICAN BUILDINGS SURVEY  
CAMP CLEAWOX ORGANIZATIONAL TRACT

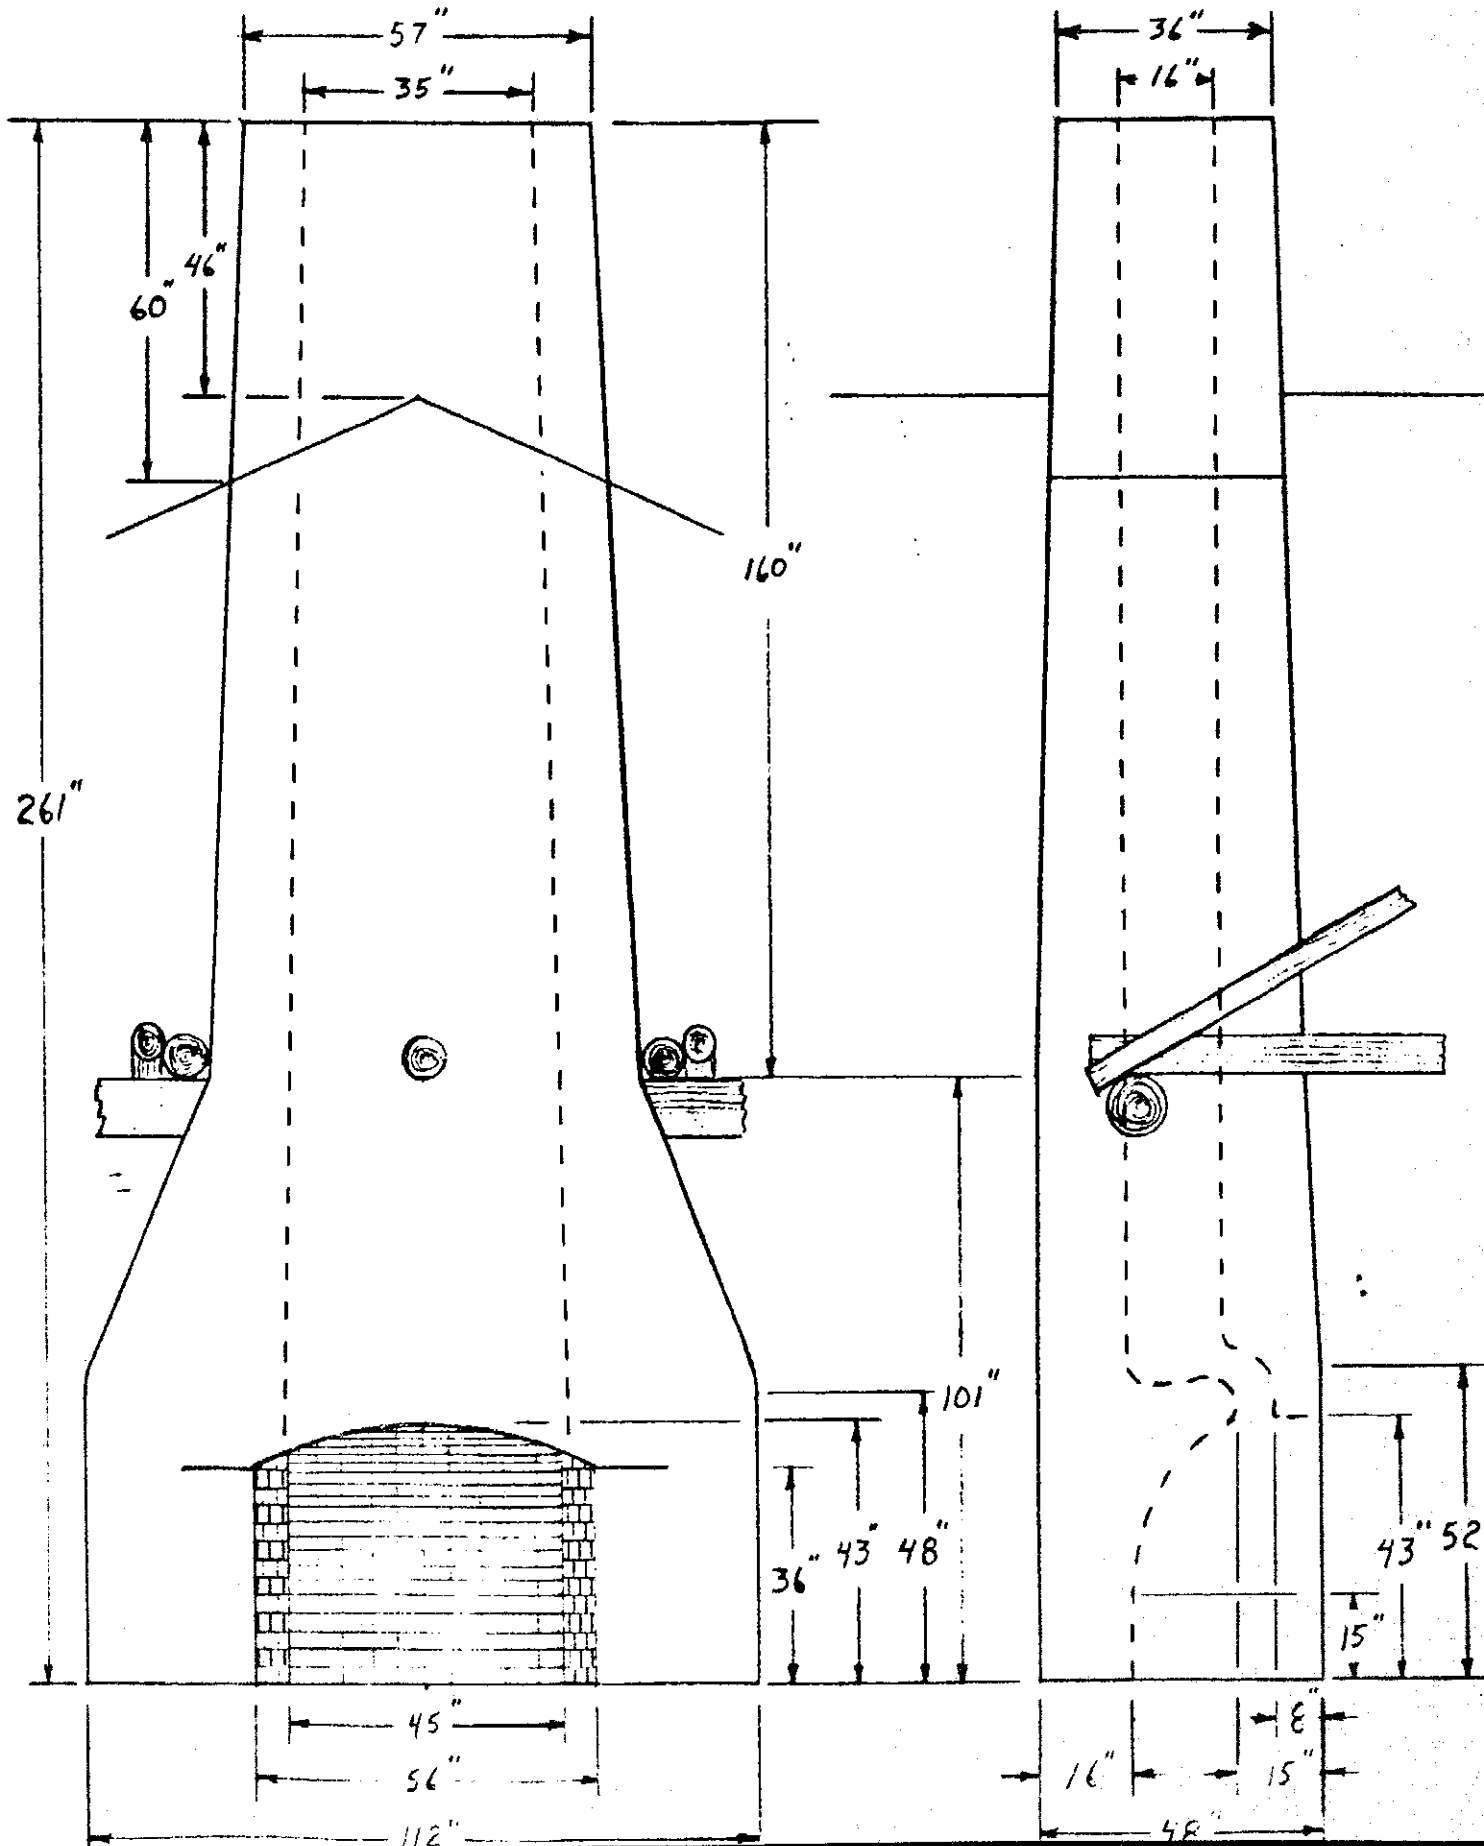
# CAMP CLEAWOX FIREPLACE

In March 1982, a corner of the fireplace foundation fell off, enabling a view of the interior substructure. Subsequent inspection showed that the southwest corner of the chimney foundation had settled sufficiently to cause cracks in the fireplace structure. The concrete leveling slab immediately below the fireplace was also cracked in three places. In addition, the supporting cedar timbers that could be seen were badly deteriorated. Further investigation suggested that the entire substructure was unsafe, and that the approximately 25 ton fireplace had very little actual support. The strength of the fireplace mortar was also questionable. Possible repair alternatives were considered, but the safety risks of performing any of the repair methods were great, and the chance of success low. Consequently, it was decided to dismantle the fireplace and replace it with a wood heater and metal flue which are in use today.

As built, the fireplace was based on an unreinforced concrete slab, 6' by 12', poured on natural ground. Cedar timbers approximately 8 feet in length and varying in diameter from 16 inches to 28 inches were placed uprightly on the slab. Rocks and stone rubble filled the voids between the cedar timbers. A concrete facing was poured around the timbers and an unreinforced concrete leveling slab poured on top. The encasing concrete apparently was poured in many segments, resulting in poor jointure.
